## Vacuum Check

### *For UniPrint121EB ALA Machines*

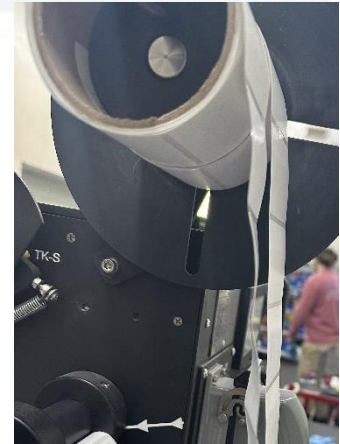
2. Labels that are cupping. Although this can happen at any time it happens most as the roll of labels gets closer to the core. As in this picture, you will see that as the labels come off the outside roll the label retains the same shape as the core as opposed to the roll on the inside that is much straighter. This can cause the label to fall off the blow head after the label is dispensed because the label will not lie flat.

If you have labels that are cupped, try a roll that doesn't have cupping labels.

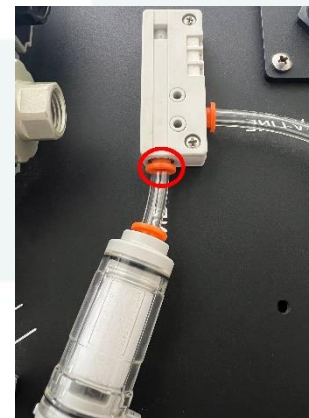
3. Make sure the mac valve is working by:
  - a. First removing the 1/4" tubing from the Pline input to the vacuum generator.

Do this by pushing in the orange ring and pulling the tubing out.

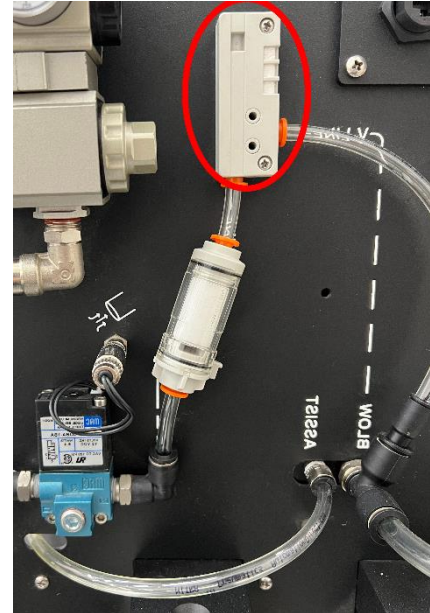
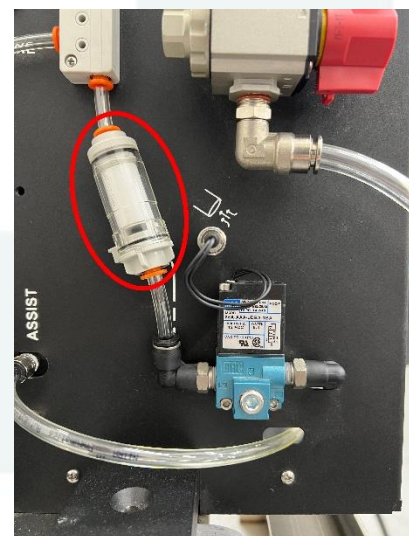
5. To help filter the air before the vacuum generator, we suggest you insert an air filter where the old check valve resided. *Please note that this filter will not stop liquids but will stop debris that could clog the vacuum generator.* This can be purchased in Coupa # 7187558.
